In Situ Analysis of Plaster Detachment by Impact Tests

Alessandro Grazzini

Abstract: The frescoed surfaces of historical buildings may be subject to detachment due to various causes of deterioration. A new non-destructive experimental methodology is described to assess in situ the safety against plaster detachments from historical wall surfaces. Through small and punctual impacts exerted with a specific hammer on the plastered surface it is possible to evaluate the level of the plaster's detachment. A case study at Palazzo Birago in Turin (Italy) is described to give an example of the application of this innovative technique on frescoed surfaces of historical vaults. The test allows to evaluate the safety of frescoed decorations without affecting the material consistency or creating damage, therefore, making it very suitable in the field of architectural heritage.

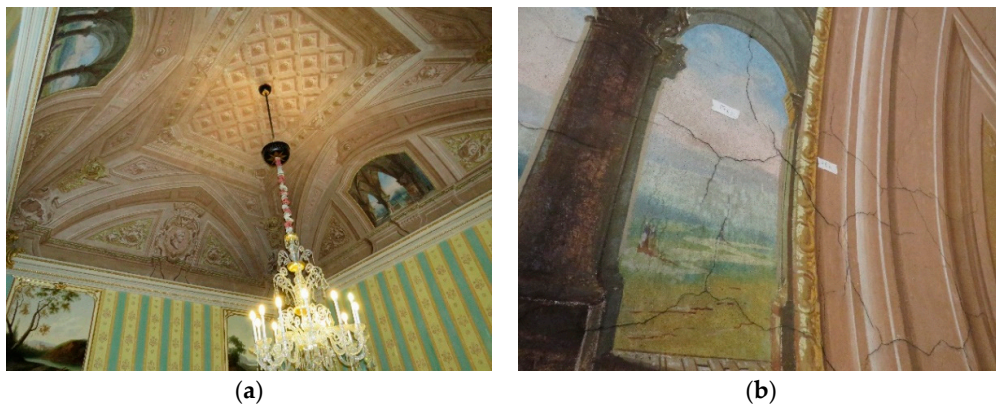
Figure 1. (a) Pelagi room at Birago Palace; (b) cracks branched in the decorated plaster of the masonry vault in the Pelagi room.

An experimental analysis of the stability of the decorated plaster covering three masonry vaults of the Birago Palace (16th century, planned by Filippo Juvarra) in the center of Turin was described by the use of the impact method test. The frescoed vaults of the Pelagi, Blu, and Giunta rooms showed some small cracks branched out in a layer of plaster that needed an evaluation regarding the risk of detachment (Figures 1–3). Surveys carried out on several points of the vaulted surfaces allowed mapping of the points of potential detachment of the de-coated plaster.

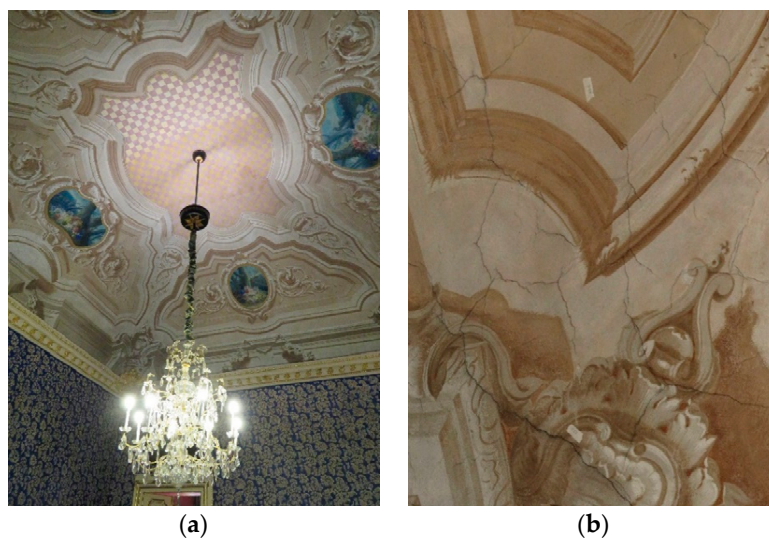
Figure 2. (a) Blu room at Birago Palace; (b) cracks branched in the decorated plaster of the masonry vault in the Blu room.

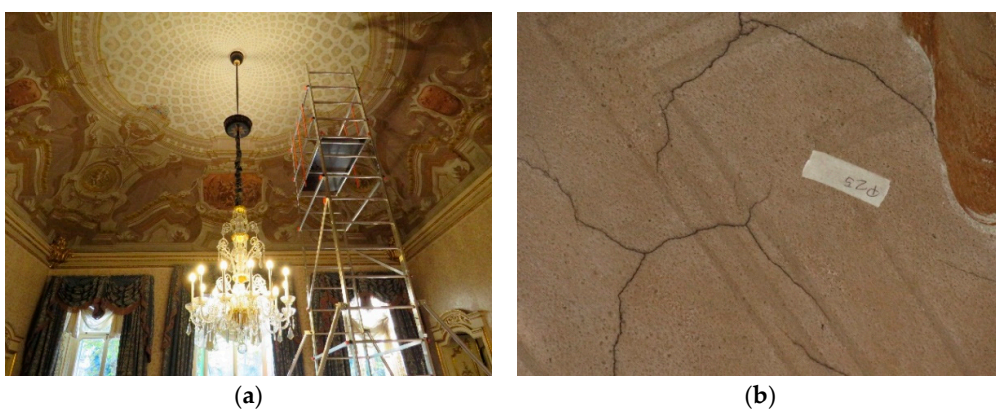
Figure 3. (a) Giunta room at Birago Palace; (b) cracks branched in the decorated plaster of the masonry vault in the Giunta room.

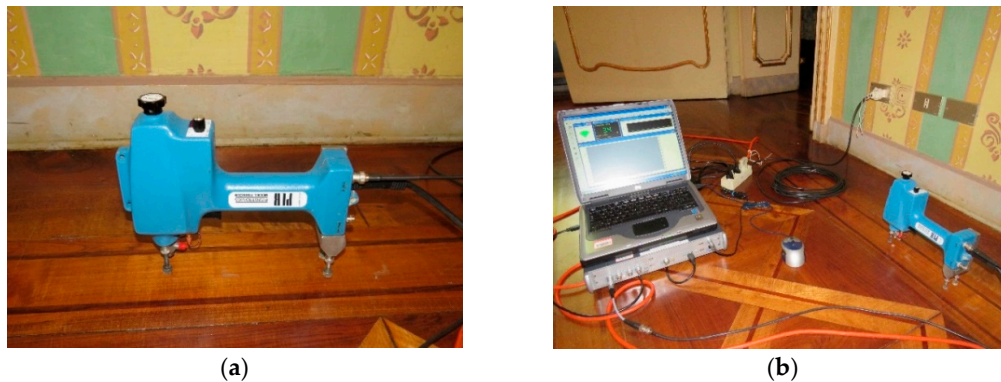
The instrumentation used to carry out the tests consisted of an impact instrumented hammer and a data analyzer. The electric impact hammer used was: PCB Piezotronics; model 086B09; force variable from 44.48 N to 4448.26 N; 208M51 model PCB force sensor; force sensor sensitivity 2.47 mV/N

(Figure 4a). The electric impact hammer was predetermined energy, characterized by the presence of one amplifier level and impedance adapter and a spherical head (10 mm diameter) in cemented steel rigidly connected to a piezoelectric impulse transducer with a total mass of 207 g.

Figure 4. (a) The electric impact hammer; (b) the LMS Pimento multi-channel signal analyzer.

The LMS Pimento multi-channel signal analyzer, with the “real-time” acquisition and recording function, had the following characteristics: model MSP 424; number of channels 4; input range: $\pm 316 \text{ mV} \div \pm 31.6 \text{ mV}$; 24-bit ADC (analog digital converter); bandwidth greater than 20 kHz (on all channels); signal sampling rate up to 100 ksample/second; and personal computer interface: FireWire IEEE1394—managed by its own dedicated software (Figure 4b).

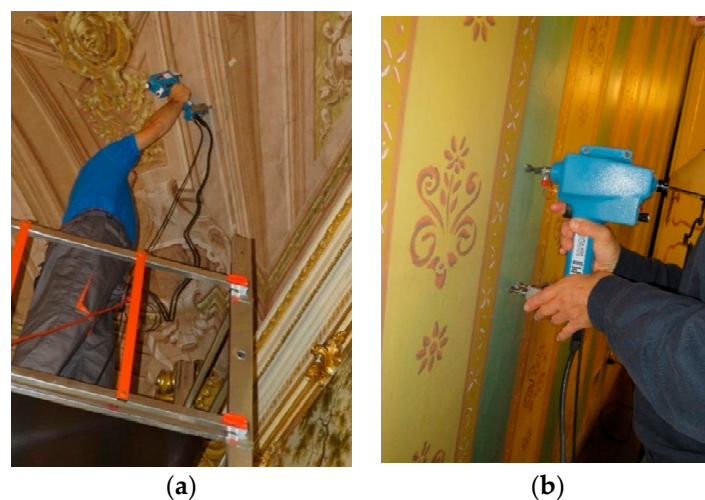
The points of the vault were randomly selected according to the logistic possibilities of movement inside the three rooms through mobile scaffolding. Most of the points chosen were found inside the cracked areas where there was a need to evaluate the adherence of the plaster on the masonry vault. Several points were also analyzed in non-cracked areas in order to compare the experimental results with the cracked points. For each point, at least three acquisitions were made to improve the statistical data (Figure 5a). For each single point test, the instrumented hammer was positioned with the impact mass perpendicular to the test surface. The perpendicularity was achieved by means of the four metallic footsies (Figure 5b). The test consisted in generating a small impact of the hammer’s mass against the test surface, with an absolutely non-destructive intensity, and therefore, also compatible with the conservation of the frescoed surfaces. The impact was triggered by a trigger control on the electric impact hammer.

Figure 5. (a) Use of the electric impact hammer for the adherence test of the frescoed plaster of the masonry vaults at Birago Palace; (b) calibration test where it is possible to see the positioning of the electric impact hammer on the test surface.

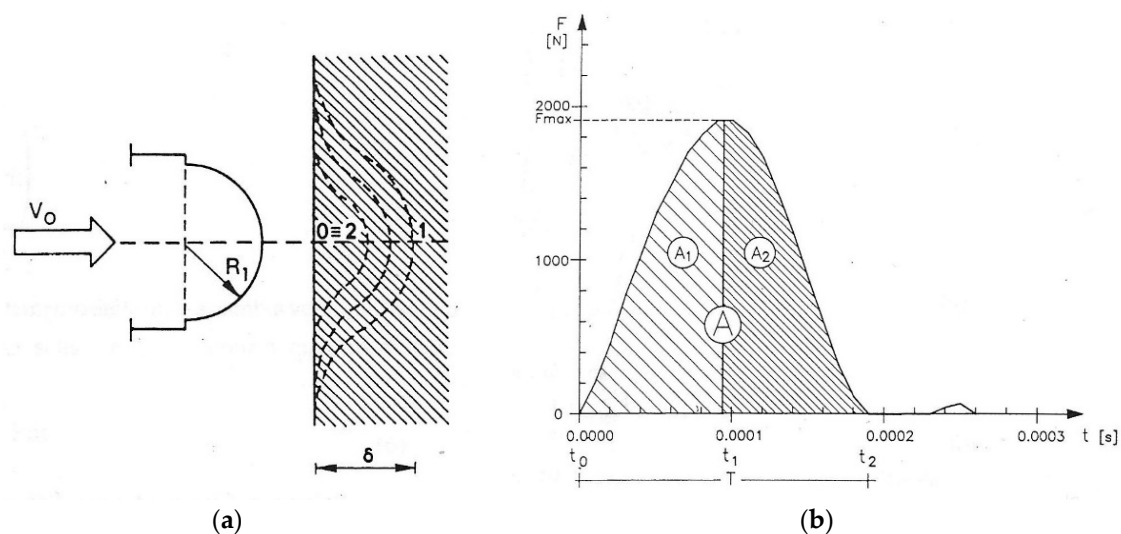
Considering the instant t_0 in which the mass touches the surface and the instant t_1 in which the maximum contact deformation δ occurs and in which the velocity v_0 is canceled (Figure 6a), the corresponding momentum variation results:

The force impulse is given by the area A_1 subtended to the curve (F, t) obtained experimentally as shown in the Figure 6b.

Figure 6. (a) Geometry of the mobile mass; (b) force–time curve obtained from an impact test.

Figure 6b shows that the return coefficient is given by the following equation:

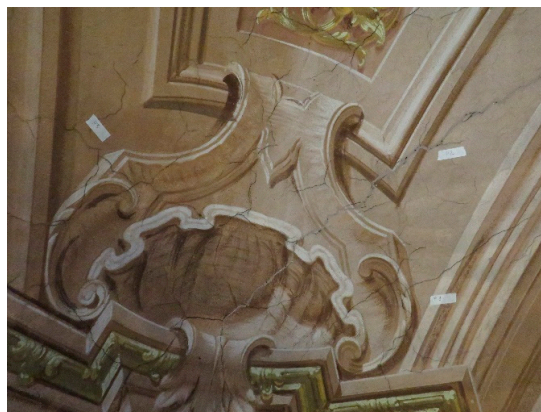
In the impact test carried out at Birago Palace in Turin (Italy), every masonry vault was divided into survey areas as shown in Figure 7, labeled with alphabet letters, within which both apparently intact and potentially damaged points were tested. For each point, at least three impacts were performed to obtain a better statistical response, and the return coefficient e was evaluated. The maps of the areas tested and the force–time curves of some tested points are shown, respectively, in the Pelagi (Figures 8 and 9), Blu (Figures 10 and 11), and Giunta rooms (Figures 12 and 13). Tables 1–3 show the coefficient averages for each point.

Figure 7. Survey area on the Pelagi room vault.

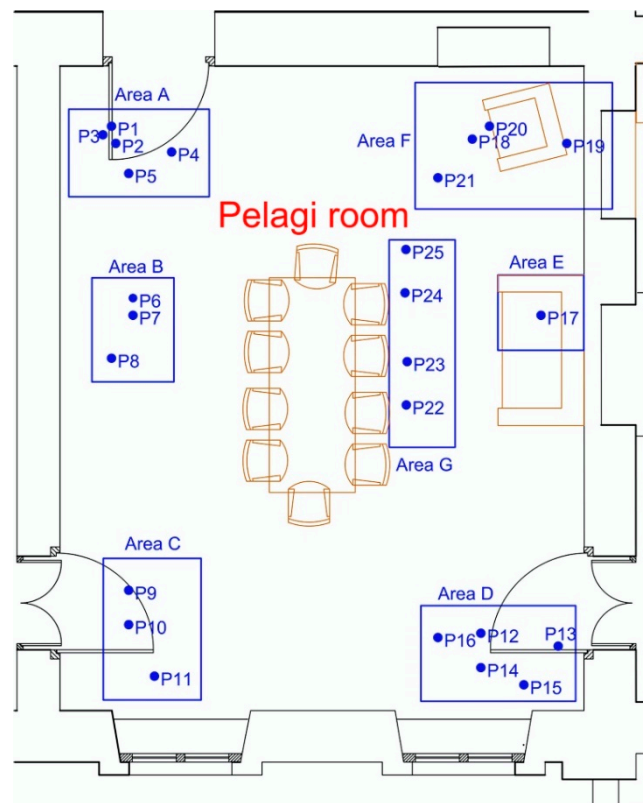
Figure 8. Map of the points and areas tested on the vault of the Pelagi room.

Area	Test Point	$e = A_2/A_1$	Notes	Adhesion Plaster
A	P1	0.77		safe
	P2	1.21	stuccoing	not safe
	P3	0.83		safe
	P4	1.08		not safe
	P5	1.33	stuccoing	not safe
B	P6	0.74		safe
	P7	0.73		safe
	P8	0.71		safe
C	P9	0.66		safe
	P10	0.91		safe
	P11	1.36		not safe
D	P12	0.66		safe
	P13	0.62		safe
	P14	0.65		safe
	P15	0.73		safe
	P16	0.75		safe
E	P17	0.91		safe
F	P18	0.69		safe
	P19	0.73		safe
	P20	1.43		not safe
	P21	0.68		safe
G	P22	0.60		safe
	P23	0.62		safe
	P24	1.19		not safe
	P25	0.69		safe

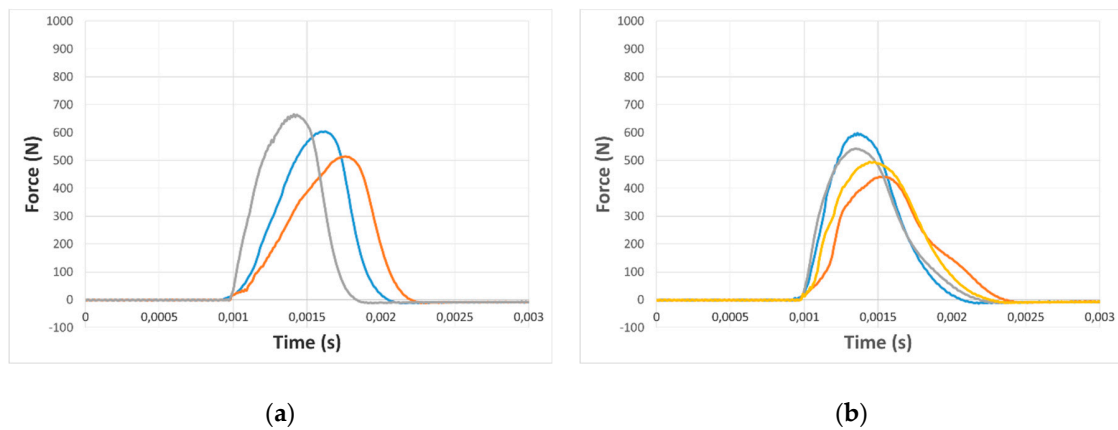
Figure 9. Impact test on Pelagi room vault: force–time curve of (a) P13 test; (b) P5 test.

The points where the plaster was still adherent to the wall surface showed more symmetrical and regular force–time curves, with higher values than the maximum impact force as the material was more compact (Figures 9a, 11a and 13a). On the contrary, in the points already covered by previous

stuccoing, lower values of the maximum force and more asymmetric curves were recorded in which the area after maximum force was greater than that which preceded it (Figures 9b, 11b and 13b).

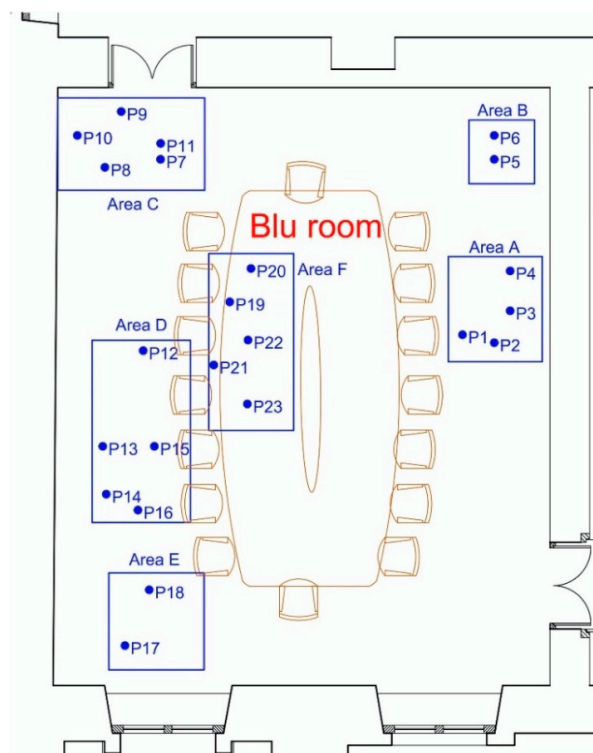
Figure 10. Map of the points and areas tested on the vault of the Blu room.

Area	Test Point	$e = A_2/A_1$	Notes	Adhesion Plaster
A	P1	0.68	Stuccoing	safe
	P2	0.75		safe
	P3	0.71		safe
	P4	1.98		not safe
B	P5	0.78		safe
	P6	0.65		safe
C	P7	0.77		safe
	P8	0.76		safe
	P9	0.84		safe
	P10	0.79		safe
	P11	0.78		safe
D	P12	0.75		safe
	P13	1.11		not safe
	P14	0.87		safe
	P15	0.70		safe
	P16	0.56		safe
E	P17	0.83		safe
	P18	0.63		safe
F	P19	0.72		safe
	P20	0.66		safe
	P21	0.66		safe
	P22	0.70		safe
	P23	0.73		safe

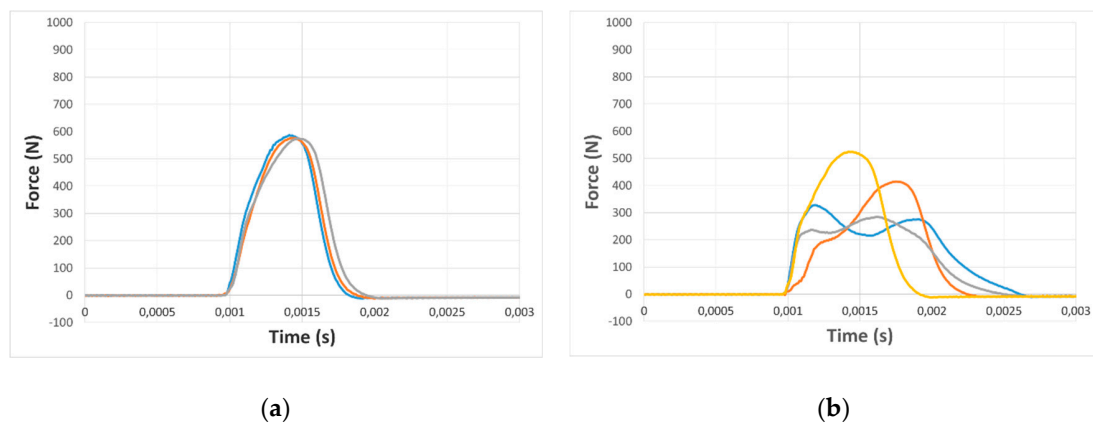
Figure 11. Impact test on Blu room vault: Force–time curve of (a) P7 test; (b) P4 test.

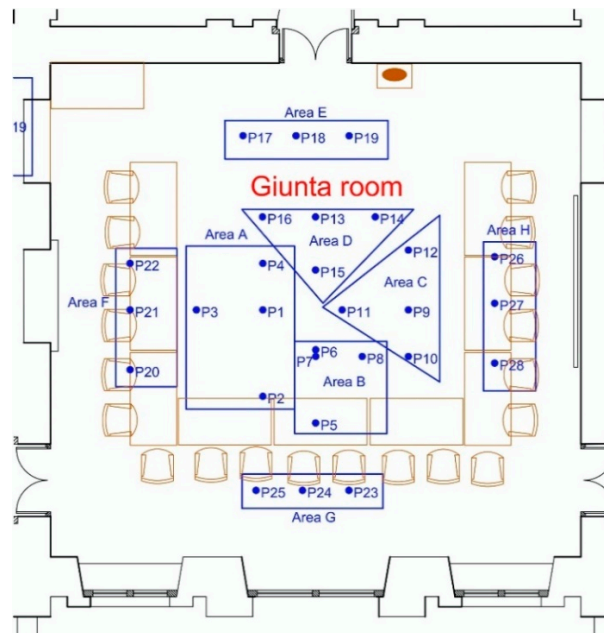
**Figure 12.** Map of the points and areas tested on the vault of the Giunta room.

Area	Test Point	$e = A_2/A_1$	Notes	Adhesion Plaster
A	P1	0.68		safe
	P2	0.74		safe
	P3	0.70		safe
	P4	0.65		safe
B	P5	0.84		safe
	P6	0.73		safe
	P7	0.72		safe
	P8	0.77		safe
C	P9	0.93		safe
	P10	0.70		safe
	P11	0.80		safe
	P12	0.72		safe
D	P13	0.65	Wiring channel	safe
	P14	0.78		safe
	P15	1.07		not safe
	P16	0.74		safe
E	P17	1.04	Stuccoing	not safe
	P18	1.26		not safe
	P19	0.70		safe
F	P20	0.74		safe
	P21	0.74		safe
	P22	0.68		safe
G	P23	0.66		safe
	P24	0.62		safe
	P25	0.77		safe
H	P26	0.75		safe
	P27	0.71		safe
	P28	0.62		safe

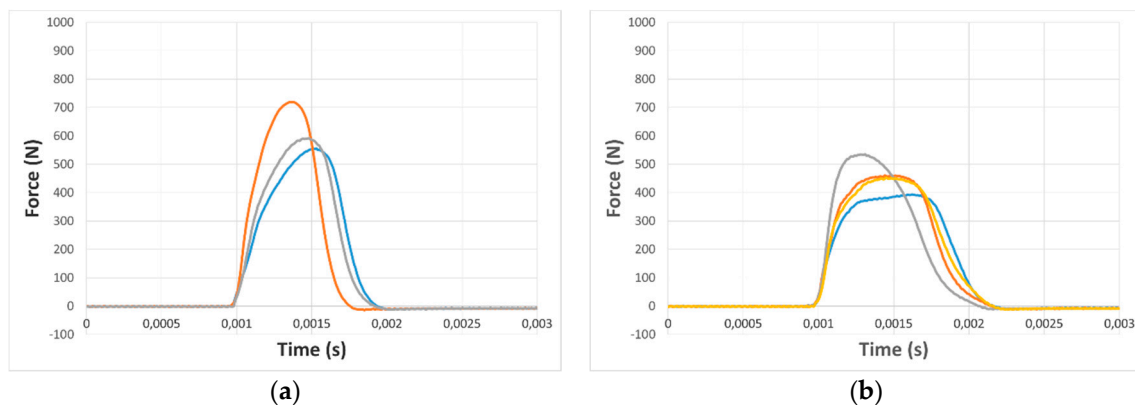
It is possible to observe that most of the points tested had a return coefficient e lower than 1. This means that the energy returned was lower than that emitted, because part of this energy was dissipated by the tested structure through sufficient bonds in the interface between the plaster and the masonry surface. On the contrary, the return coefficient $e > 1$ showed a returned energy greater than the one emitted: in this case the material was already damaged [4,5] because it was partly or

completely disconnected and returned more energy due to the deformations and the microscopic movements active due the non-perfect adherence between plaster and masonry surface.

Figure 13. Impact test on Giunta room vault: force–time curve of (a) P4 test; (b) P15 test.

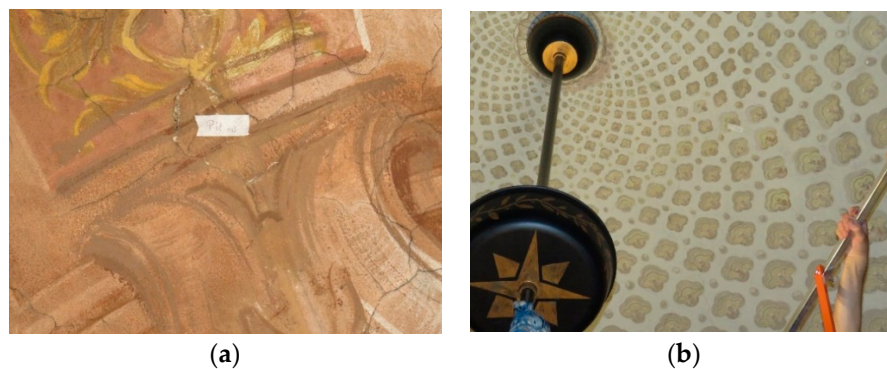
On the masonry vault of the rooms some points of potential detachment of plaster have been found, characterized by a return coefficient $e > 1$ (Tables 1–3). These results were in agreement with what has been possible to perceive qualitatively with a simple hand knock on the point under investigation. Some of these points with a high return coefficient were stuccoed previously, a sign that some critical issues of potential detachment already existed in the past (Figure 14). In some cases, as for point P15 of the Giunta room, the impact method confirmed the presence of an installation channel that feeds the chandelier as a zone with weak adherence of the plaster (Figures 13b and 14b).

Figure 14. Points of potential plaster detachment: (a) P11 vault Pelagi room; (b) P15 vault Giunta room.

The decorated surfaces of the vaults therefore appeared to be in a good state of conservation. The ramified cracks present in most of the surface derive from the shrinkage effects of the historical plaster mortar, due to different reasons: climatic conditions, setting of the binders (lime and cement), binder/inert quantity ratio.
